# Engineering Report

Report # : Generic Vs. OEM

Date : 24.07.2003

***Subject: Laboratory Comparison of Generic  
Auto Parts with OEM Parts of Toyota Corolla 2001.***

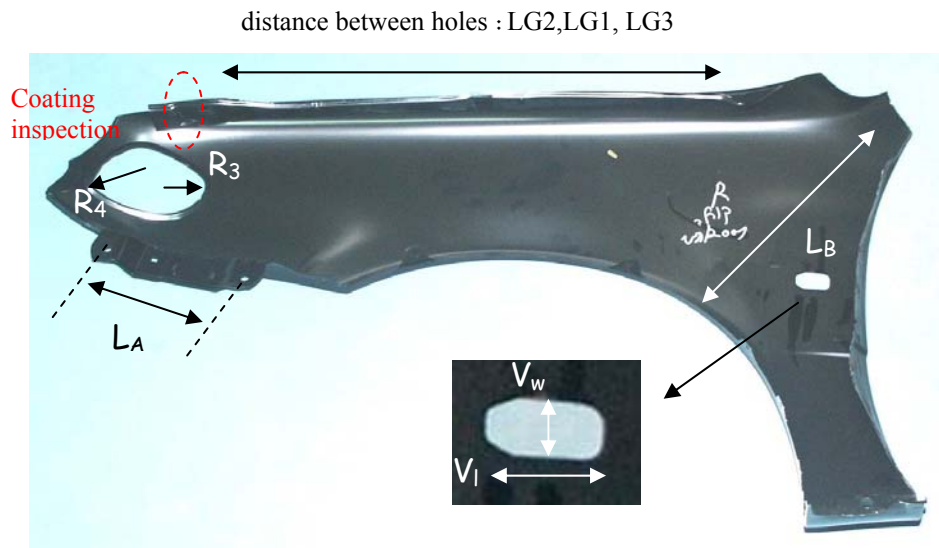
**Fig. 1:** parameters measured on the right front fender

The dimensions measured are marked on Fig. 1 in Appendix 1. The measurements were performed by Coordinate Measuring Machine (X-Y-Z system), Sip make.

Parameter	O [mm]	G [mm]
<b>R<sub>3</sub></b>	R20	R22
<b>R<sub>4</sub></b>	R9-9.5	R9-9.5
<b>L<sub>A</sub></b>	191.3	192.2
<b>L<sub>B</sub></b>	337	338
<b>L<sub>G1</sub></b>	780	780
<b>L<sub>G2</sub></b>	502.4	502.9
<b>L<sub>G3</sub></b>	45.2	No hole
<b>V<sub>I</sub></b>	46.8	46.3
<b>V<sub>w</sub></b>	27.5	29.7

- a. Deviations in length of arbitrary selected dimension  $L_A$ ,  $L_B$   $L_{G3}$  and the differences in edge radius indicates geometry differences between generic and OEM parts, exit.
- b. A significant difference was measured at the assembly winker hole: G hole is significantly bigger than O. That result may affect post assembly sealing, G-hole will enable water penetration and initiation of corrosion process.
- c. The O-part is protected by a double sided **uniform** coating that provides a better environmental protection than the G-part (on which only one **non-uniform** layer of paint).

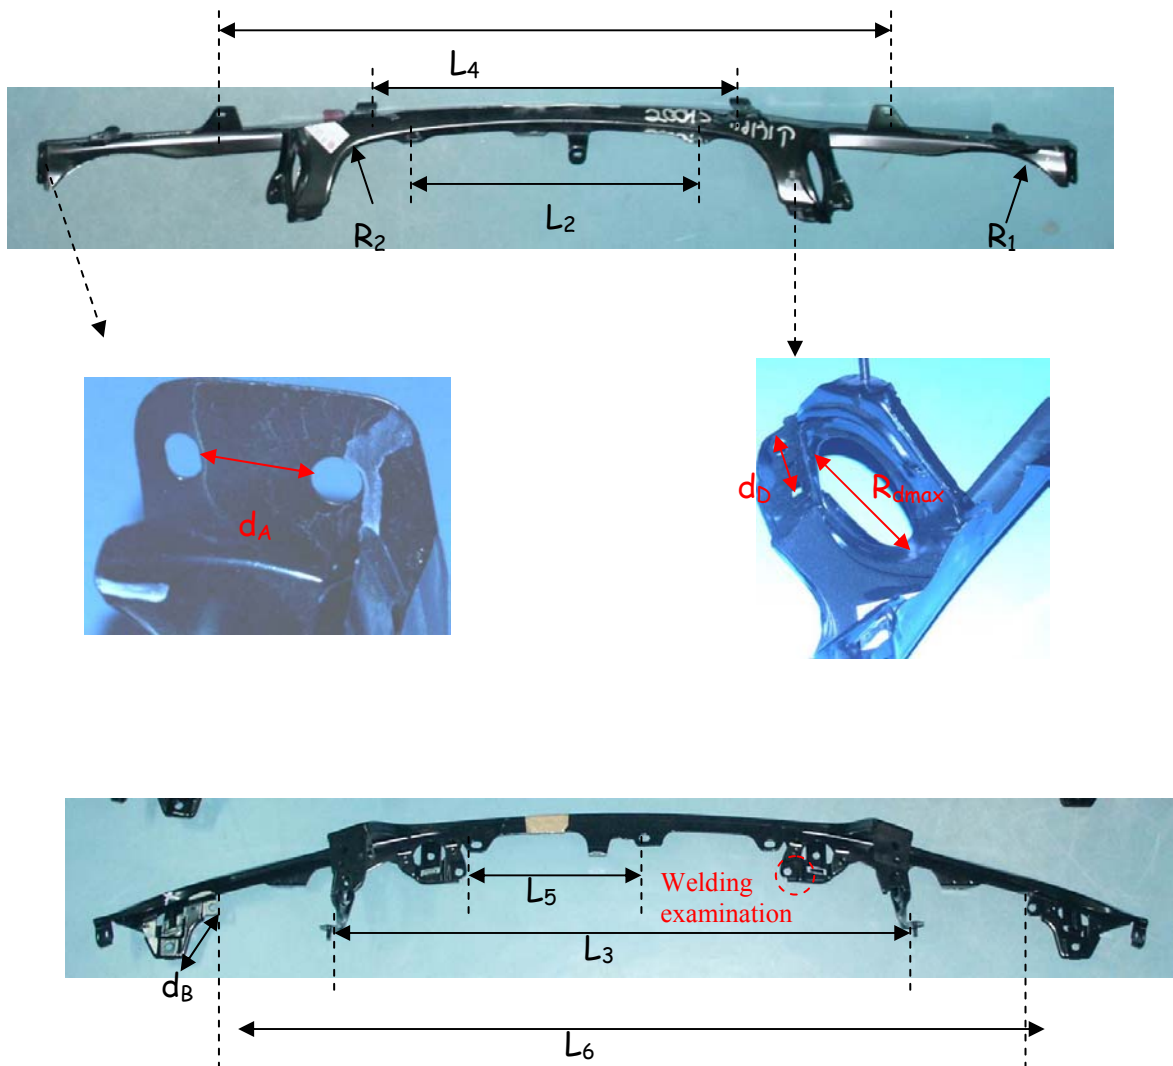
**Fig. 2:** parameters measured on the front fender

The dimensions measured are marked on Fig. 2 in Appendix 2. The measurements were performed by Coordinate Measuring Machine (X-Y-Z system), Sip make.

Parameter	O [mm]	G [mm]
$L_1$	862	866.5
$L_2$	362	362
$L_3$	725	735
$d_A$	27.5	27.5
$d_B$	74.5	74.6
$d_D$	39	36
$R_{dmax}$	79	79;78
$L_4$	417	424
$L_5$	147.2	147.2
$L_6$	1059	1066

- a.** At least in three arbitrary selected dimensions ( $L_3$ ,  $L_4$  and  $L_6$ ) an obvious deviation in geometry was verified. That fact will eventually cause assembling difficulties that will undertake component distortion by the mechanic
- b.** The significant changes between parts in both spot weld quality (lower size and roundness in the G-part) and sheet thickness (G is thinner) implies that the G-component is weaker in strength up to 30% relative to O-component.

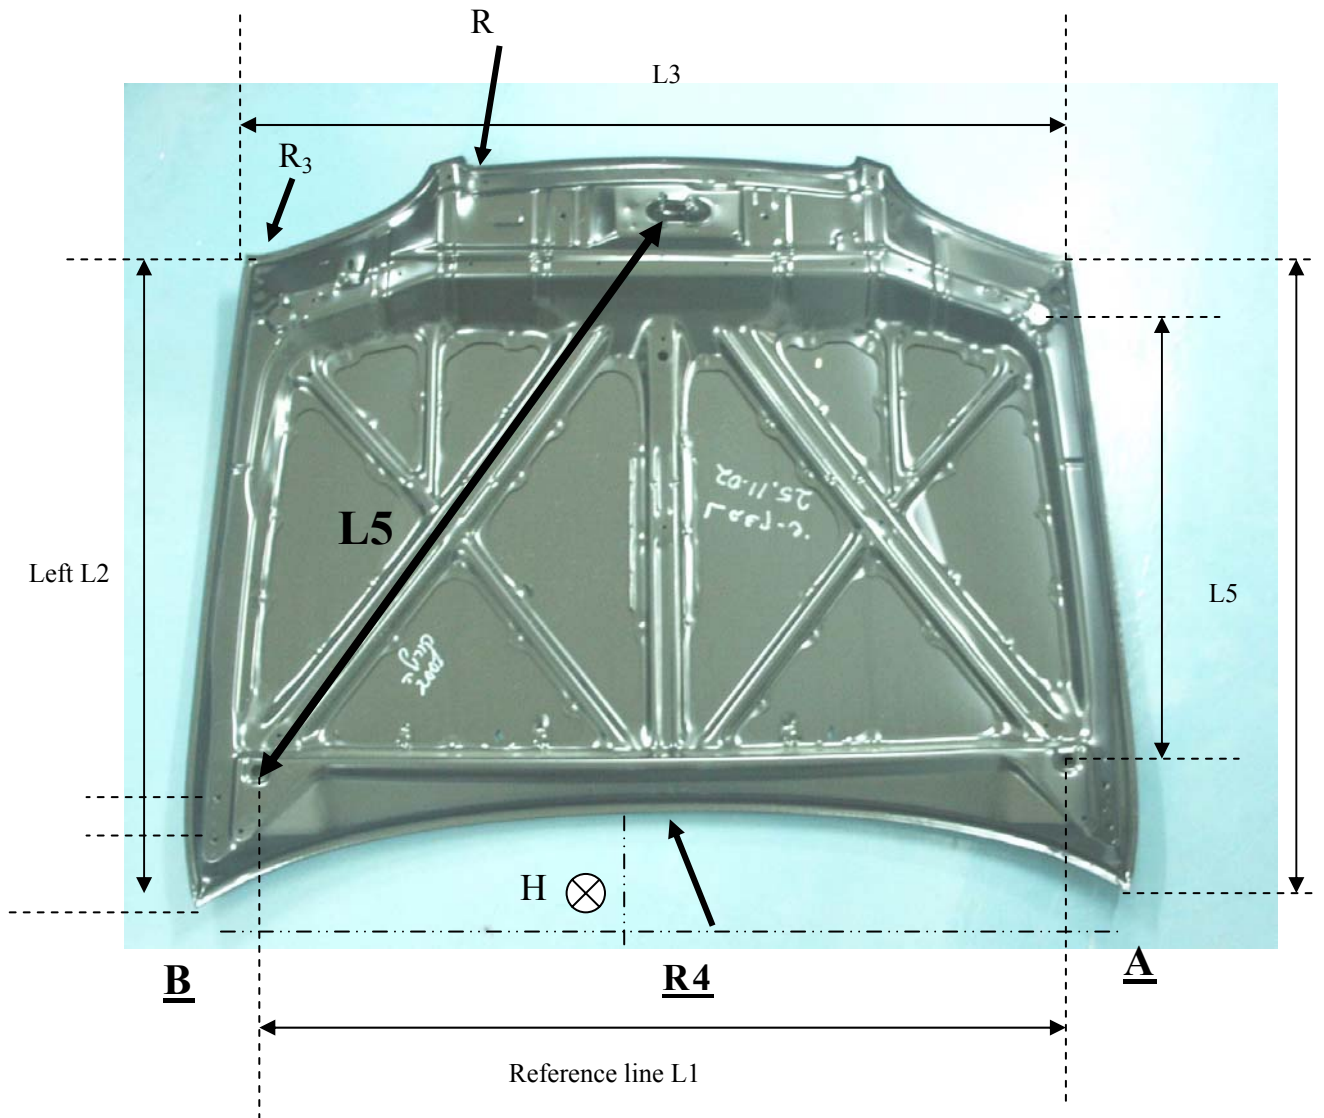
**Fig. 3:** parameters measured on hood.

The dimensions measured are marked on Fig. 3 in Appendix 3. The measurements were performed by Coordinate Measuring Machine (X-Y-Z system), Sip make.

Parameter	O [mm]	G [mm]
<b>L<sub>1</sub></b>	1179.8	1179.8
<b>Right L<sub>2</sub></b>	1000.0	1000.6
<b>Left L<sub>2</sub></b>	1000.03	998.3
<b>L<sub>3</sub></b>	1303.5	1302.5
<b>L<sub>4</sub></b>	60.0	60.5
<b>L<sub>5</sub></b>	740.0	740.7
<b>L<sub>6</sub></b>	1058.4±0.2	1058.2±0.2
<b>R<sub>1</sub></b>	14	15-16
<b>ΔR<sub>3</sub></b>	Δ1.5	
<b>ΔH</b>	Δ4

**Note:** H is the height between imaginary line A-B and mid radius R<sub>4</sub>.

- a. Significant differences in dimensions {of  $L_2$  and of height clearance of 4 mm ( $\Delta H$ )} will create curvatures on the hood during assembling. Furthermore, a noticeable gap between the hood and its seat is expected to remain. Such a gap may be fixed only by excessive work of the technician in the car depot.

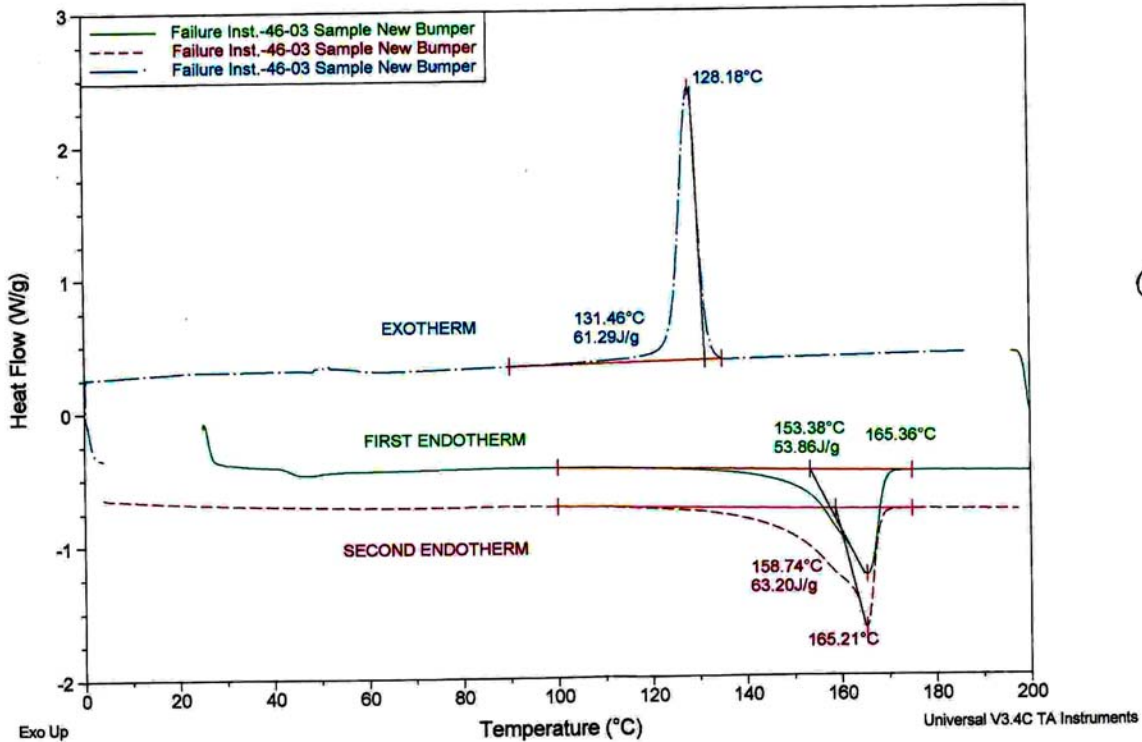
Note: See DSC thermograms of both materials in appendix 4

- b. The thermal analysis measured lower level of crystallinity of O than G. The consequence is that O is more flexible and better in impact energy absorbing. These results conform to the behavior of the specific materials under impact loading test: the G samples fractured during the test, while the O-samples bent without fracturing.

**O – bumper with low crystallinity**

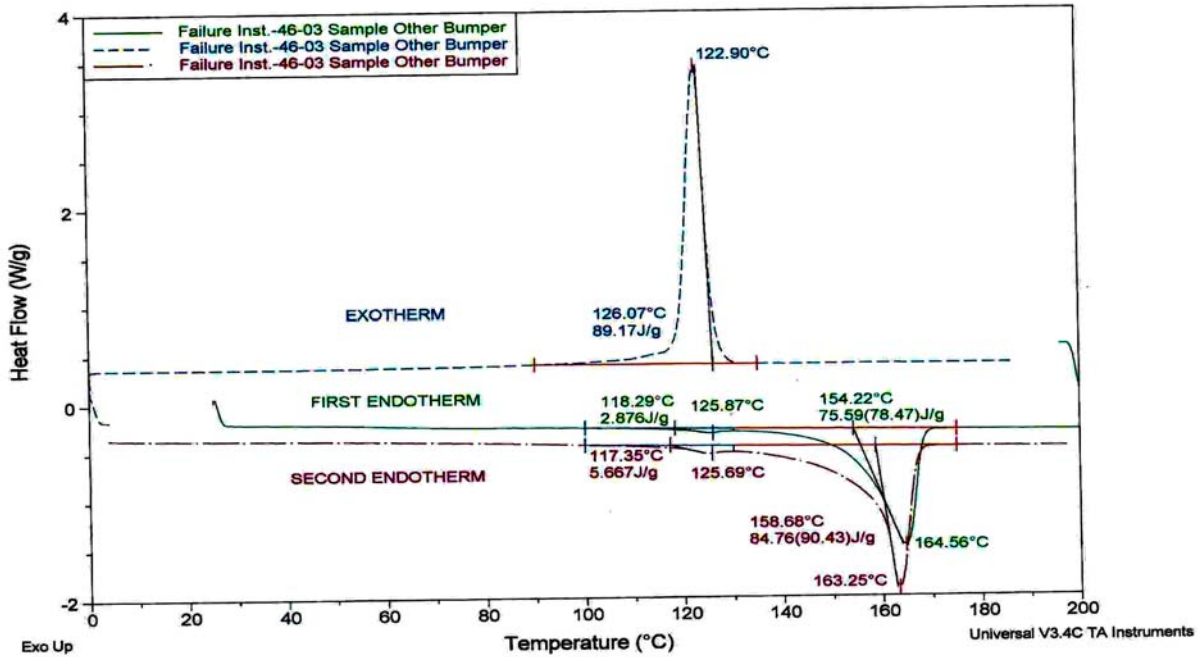
**G – bumper with high crystallinity**
